Manhole Inspection Summary

Manhole # S53I__032MH

Insp Date: **4/11/08 2:04 PM**

Location Address: **rear 516 s. clinton st**

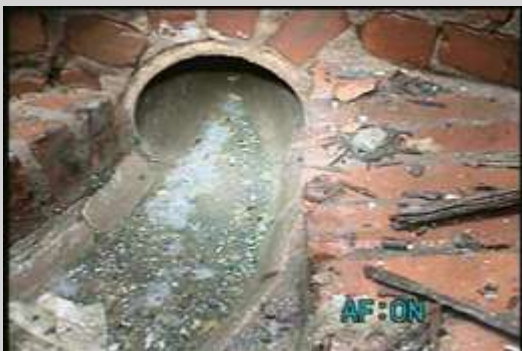
3 O'Clock Inflow

8 in. Circular Gravity Sewer
Pipe In @ 3 O'Clock

Invert Depth: **7.96** (ft.) Flow Characteristics: **Slow**

Deposits: ☒ None ☐ Mud ☐ Sludge ☐ Debris ☐ Grease

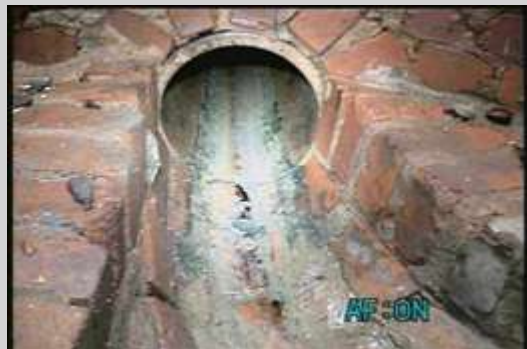
9 O'Clock Inflow

8 in. Circular Gravity Sewer
Pipe In @ 9 OClock

Infiltration: **None** Pipe Seal Cond: **Unknown**
